# Manhole Inspection Summary

Manhole # S15SS1022MH

**Location** Address: **4928 CLYBURN AVE**

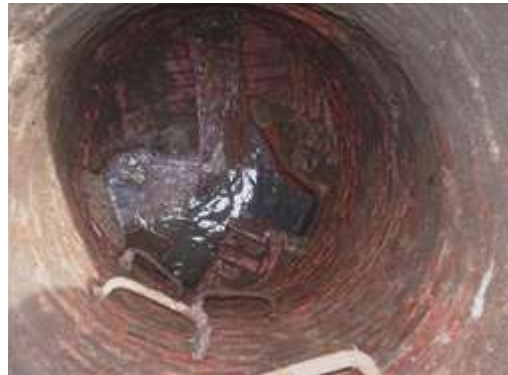
Top View

Corroded steps. Evidence of surcharge - Bench debris. Channel debris.

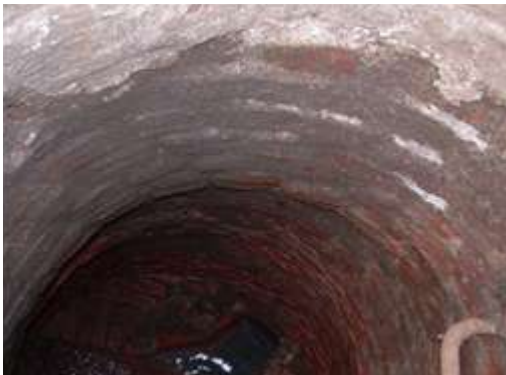
Defect

Adjustment and Barrel infiltration.

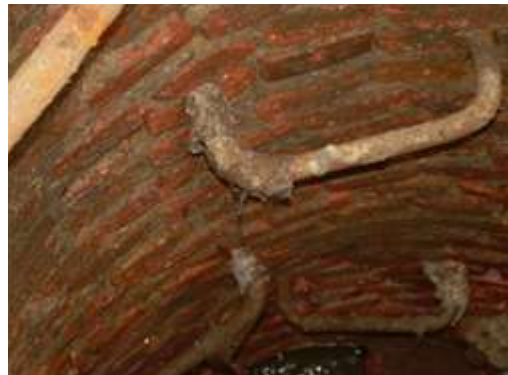
Defect

Barrel infiltration. Evidence of surcharge.

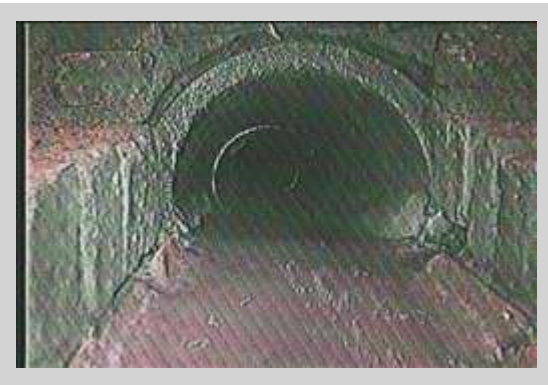
### 10 in. Circular Gravity Sewer Pipe Out @ 12 O'Clock

Channel deterioration.

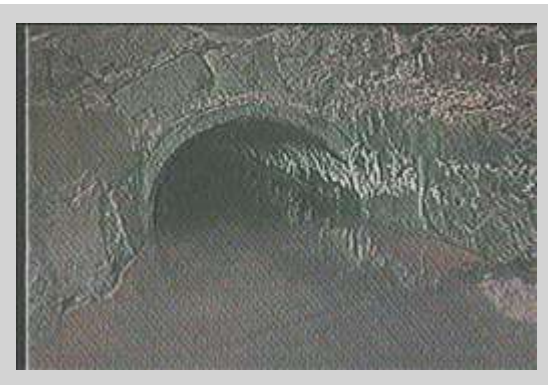
### 8 in. Circular Gravity Sewer Pipe In @ 4 O'Clock

Barrel deterioration and infiltration. Channel deterioration.

Infiltration: **Evidence** Pipe Seal Cond: **Cracked**

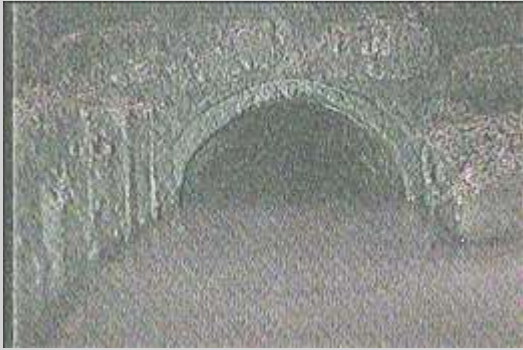
Pipe In @ 7 O'Clock

Infiltration: **Evidence** Pipe Seal Cond: **Unknown**

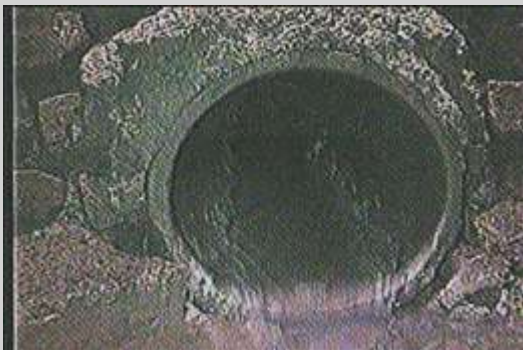
Pipe In @ 8 O'Clock

Barrel deterioration and infiltration.
